DEPARTMENT OF TRANSPORTATION

Quality Assurance and Source Inspection

Contract #: 04-0120F4Cty: SF/ALA Rte: 80 PM: 13.2/13.9File #: 99.28**WELDING INSPECTION REPORT****Resident Engineer:** Casey, William**Address:** 333 Burma Road**City:** Oakland, CA 94607**Report No:** WIR-028358**Date Inspected:** 05-Sep-2012**Project Name:** SAS Superstructure**OSM Arrival Time:** 1000**Prime Contractor:** American Bridge/Fluor Enterprises, a JV**OSM Departure Time:** 1830**Contractor:** American Bridge Manufacturing**Location:** Reedsport, OR**CWI Name:** Jim Vanek**CWI Present:** Yes No**Inspected CWI report:** Yes No N/A**Rod Oven in Use:** Yes No N/A**Electrode to specification:** Yes No N/A**Weld Procedures Followed:** Yes No N/A**Qualified Welders:** Yes No N/A**Verified Joint Fit-up:** Yes No N/A**Approved Drawings:** Yes No N/A**Approved WPS:** Yes No N/A**Delayed / Cancelled:** Yes No N/A**Bridge No:** 34-0006**Component:** Split Collars**Summary of Items Observed:**

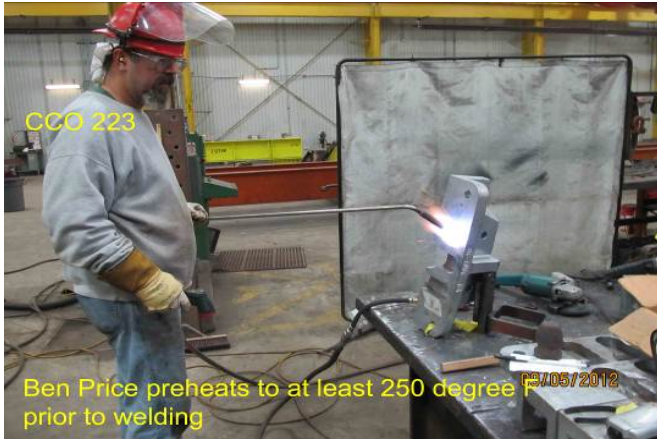
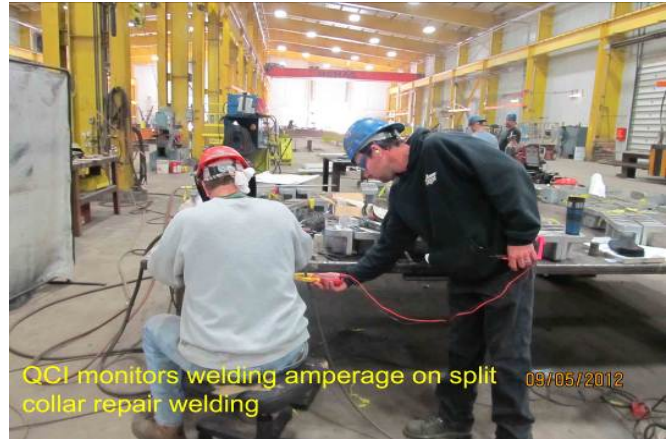
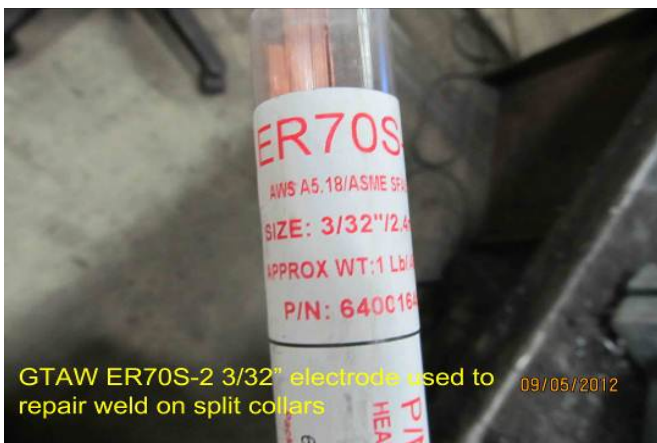
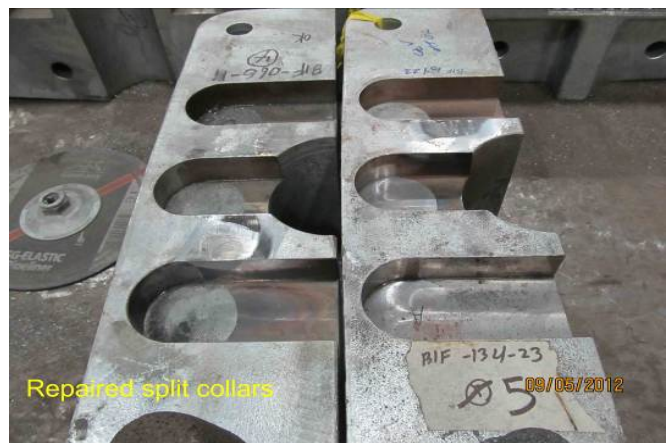
This Quality Assurance Inspector (QAI), Dan Chang, witnessed Quality Control Inspector (QCI), Jim Vanek, of American Bridge Manufacturing (ABM) monitored the repair welding of split collars of CCO 223. QCI was witnessed to monitor welding amperage, 155, and voltage, 13.7, with an Amprobe Model ACDC-100. Repair welding was performed by Gas Tungsten Arc Welding (GTAW) using ER70S-2 3/32" diameter electrode in accordance to Welding Procedure Specification (WPS) # ABM-GTAW-01. This QAI witnessed Ben Price to grind off rust within the void to bright metal and preheat to at least 250°F prior to welding using Extech mini-infrared thermometer Model 42500. This QAI verified amperage and voltage with Fluke ammeter Model 337. Repair welding on split collars were observed at regular intervals by this QAI.

Split collars from Group 5 that were completed repairing during this work shift are BIF-066-11, BIF-134-23, BIF-077-13, and BIF-523-88.

Item	Weld Identification	Applicable WPS	CWI Name	Amperage	Voltage	TravelSpeed	Preheat Temp	Remarks
1	BIF-066-11	ABM-GTAW-01	Jim Vanek	155	13.7	3 ipm	250	Void was welded and surface ground smooth
2	BIF-523-88	ABM-GTAW-01	Jim Vanek	155	13.7	3 ipm	250	Void was welded and surface ground smooth
3	BIF-077-13	ABM-GTAW-01	Jim Vanek	155	13.7	3 ipm	250	Void was welded and surface ground smooth
4	BIF-134-23	ABM-GTAW-01	Jim Vanek	155	13.7	3 ipm	250	Void was welded and surface ground smooth
